# Crompton 9W LED Bulb PRO: Teardown

*Executive summary of photographic teardown TD-2026-CRM-001 (RFC 1, Level 4)*

| <b>Document number</b> | TD-2026-CRM-001-EXECUTIVE-SUMMARY |

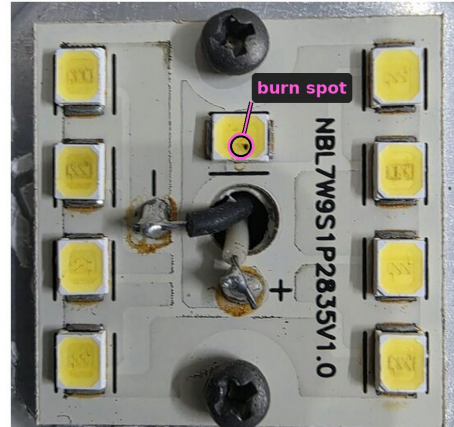
(b) LED board, 9 x 2835 in series

- a single-sided driver in the neck, NBL-DR180425V0.1,  $48 \times 24$  mm;
- a square, aluminium-backed LED board, NBL7W9S1P2835V1.0, with nine 2835 LEDs in series, screwed to an aluminium cup.

| <b>Id</b> | <b>Sev.</b> | <b>Conf.</b> | <b>Finding</b> |
|---|---|---|---|
| RISK-01 | high | 0.65 | LEDs driven ~16% over their board's printed 7 W, ~0.9 W per 2835. A <b>burn spot over a die</b> is visible on the centre LED, and a public repair video of a flickering Crompton lamp shows the same LED board with the same mark. In a series string, one open die darkens the lamp. |
